HUNGARIAN ATOMIC ENERGY AUTHORITY Nuclear Safety Bulletin

RECENT DEVELOPMENTS IN NUCLEAR SAFETY IN HUNGARY October 2015

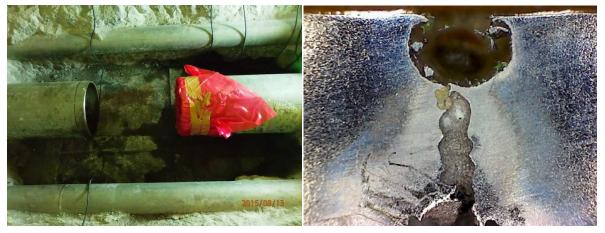
In connection with the failure due to corrosion of cooling circuits of the spent fuel pool at Unit 3 MVM Paks NPP Ltd. contracted external experts to examine the cooling pipelines of the other units. The Croatian INETEC company developed a testing device and used it to test the cooling circuits of the spent fuel pool.

The aim of the analysis is to measure the actual failure in a qualitative and quantitative manner that also gives the exact position and size of the failure zones before starting the repair. The comprehensive investigation on Units 1-4 found that the rate of corrosion varies at the individual units. Some of the most impacted cooling circuit sections were replaced in 2015. These examinations and the planned repairs, maintenance and cyclic material structure tests justified to install the same T-joints as it had been fitted at Unit 3.

Replacement of the spent fuel pool pipeline at Unit 2

Cross-section of a corrosion pit, cut from the pipeline at Unit 3
